PRELIMINARY DATA REPORT
BRENTON REEF
WELLFLEET
NORWALK
DISPOSAL SITES
AUGUST 1981

CONTRACT #
DACW33-81-C-0115

New England Division
U.S. Army Corps of Engineers
424 Trapelo Rd.
Waltham, MA 02154

The purpose of this report is to document the sampling procedures used during these surveys and to present preliminary results of these measurements.

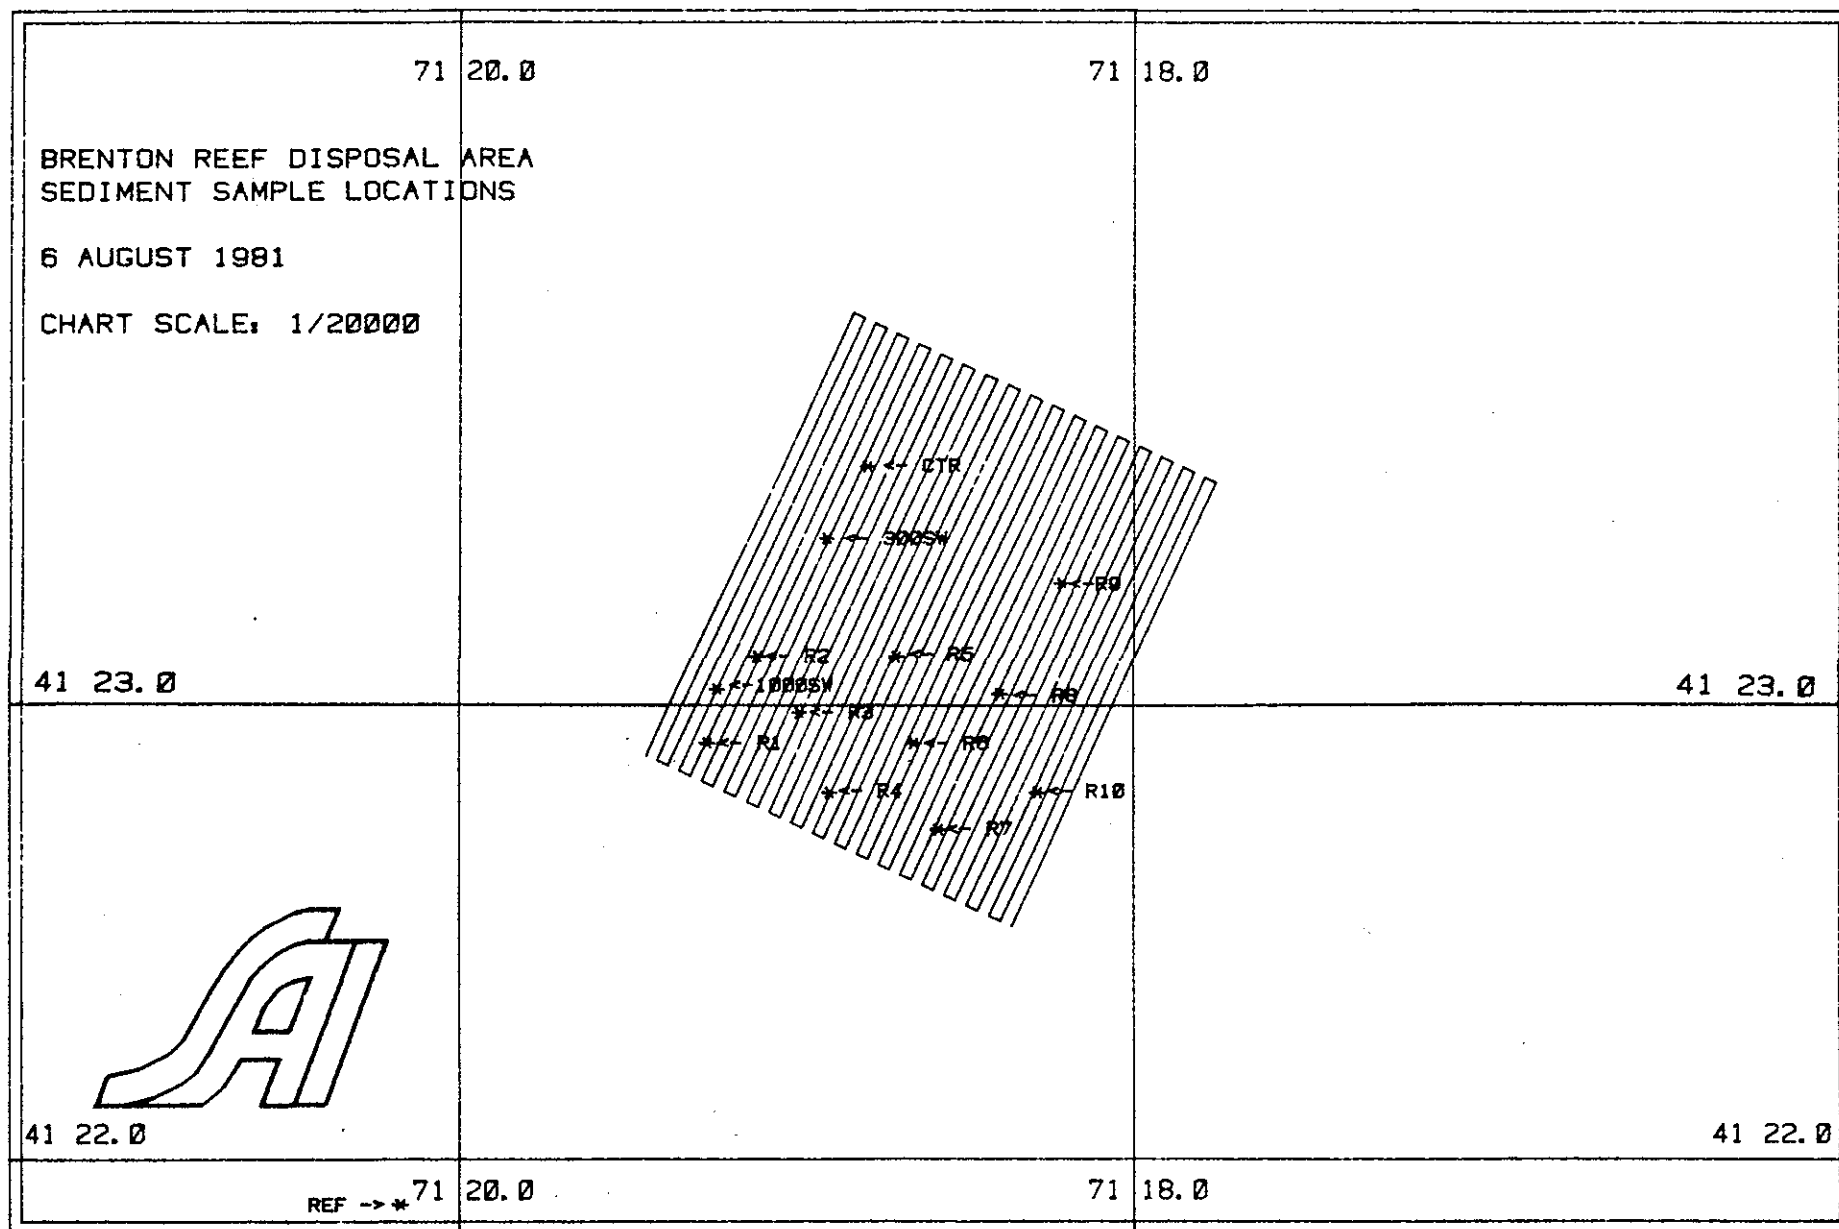
Fig. 3.0-1

On August 5, a bathymetric survey was run which covered a 3400 km^2 area centered about $41^{\circ} 23.18'N$, $71^{\circ} 18.6'W$ (Figure 3.0-1). During the survey, evidence of past dumping operations was clearly evident on the fathometer record, however, problems with analysis of the bathymetric data have prevented presentation of a complete depth contour chart at this time. Portions of the fathometer record on lanes 12 and 13 which clearly depict the spoil mound are presented in Figures 3.0-2 and 3.0-3 respectively. Complete bathymetric contour plots will be provided as soon as the analysis problems are resolved.

Sediment samples were obtained at the locations defined in Table 3.0-1 and shown in Figure 3.0-1. The distribution of samples was determined by developing a profile from the center of the disposal mound (BR-CTR) to the Reference Station (BR-REF). Based on these samples, stations on the margin of the spoil mound (BR-300SW) and on natural bottom adjacent to the spoils (BR-1000 SW) were established. Five replicates were then obtained at each of these stations for benthic analysis. In addition, random samples distributed over the south and east portions of the survey area were obtained to provide baseline data on sediment characteristics and benthic populations. At each of these random stations three replicate samples were obtained.

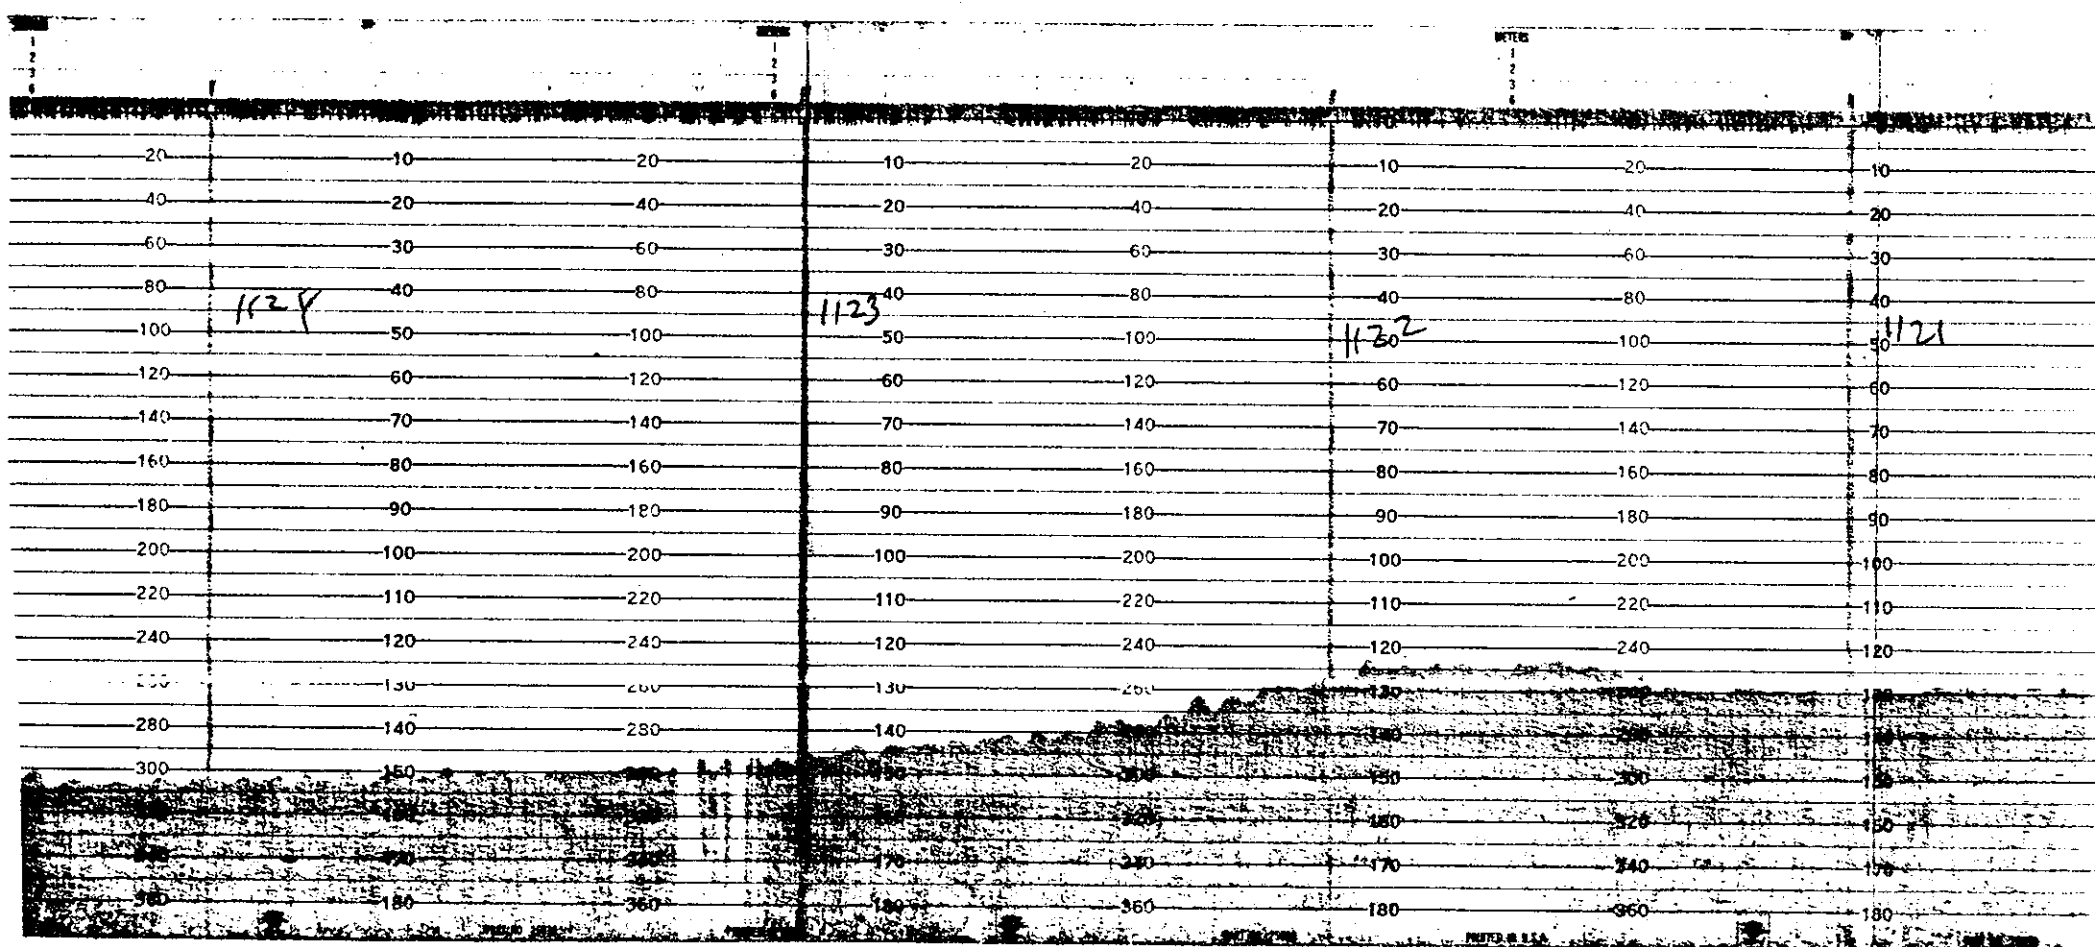
Fig. 3.0-2

VERTICAL DEPTH PROFILE
BRENTON REEF DISPOSAL SITE
LANE 12
AUGUST 1981

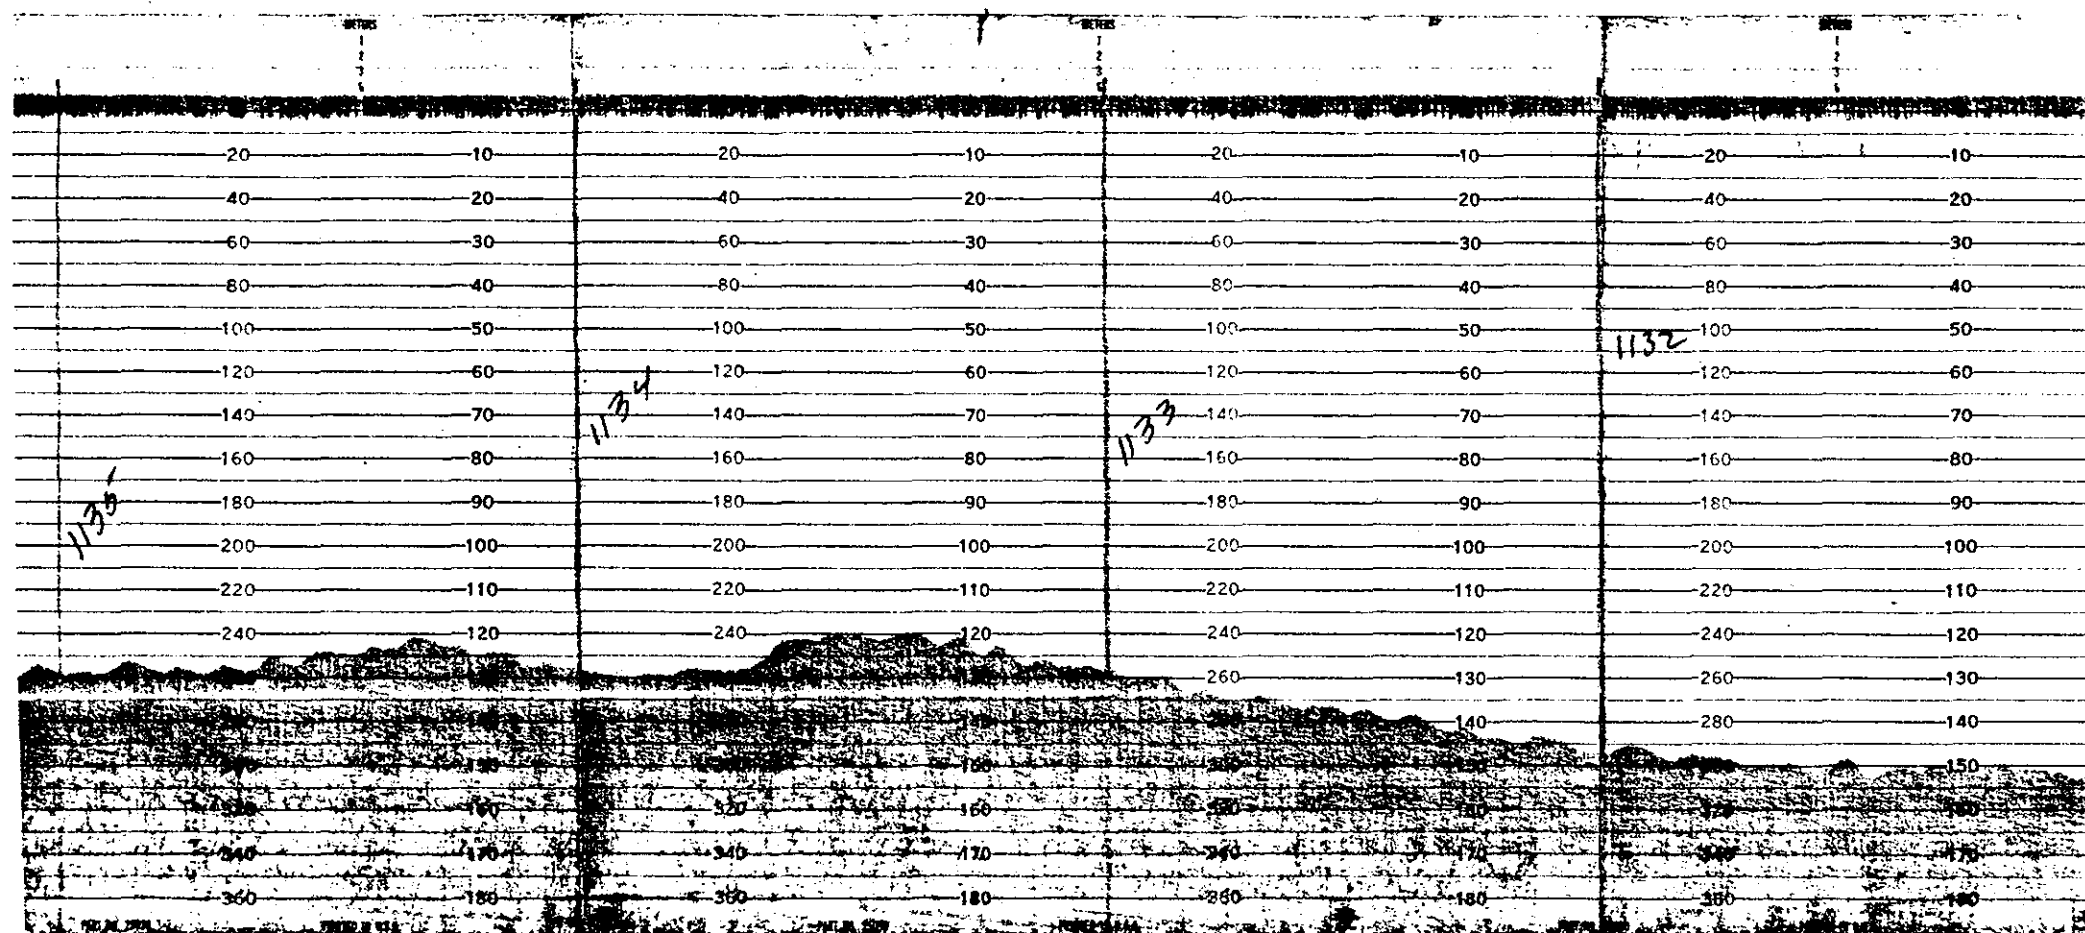
VERTICAL DEPTH PROFILE
BRENTON REEF DISPOSAL SITE
LANE 13
AUGUST, 1981

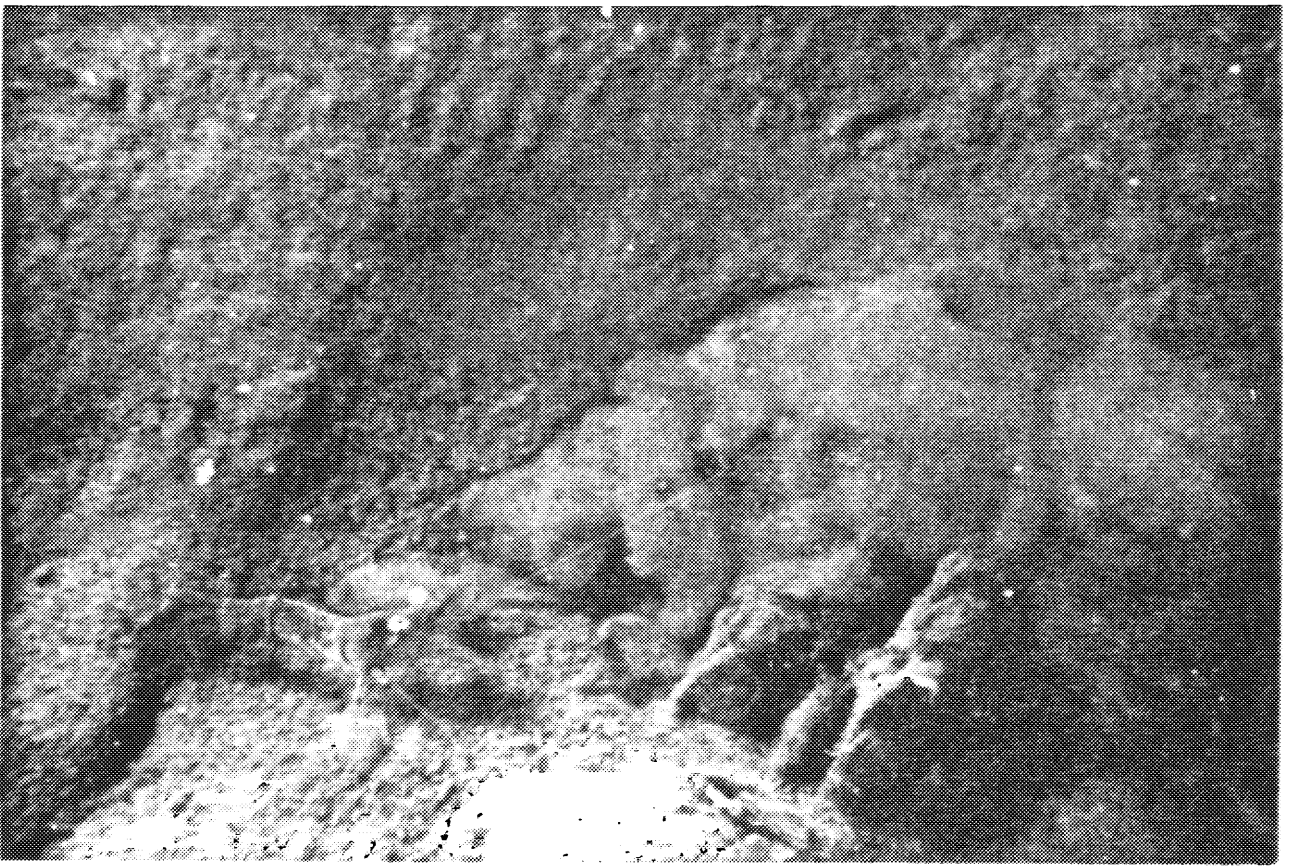
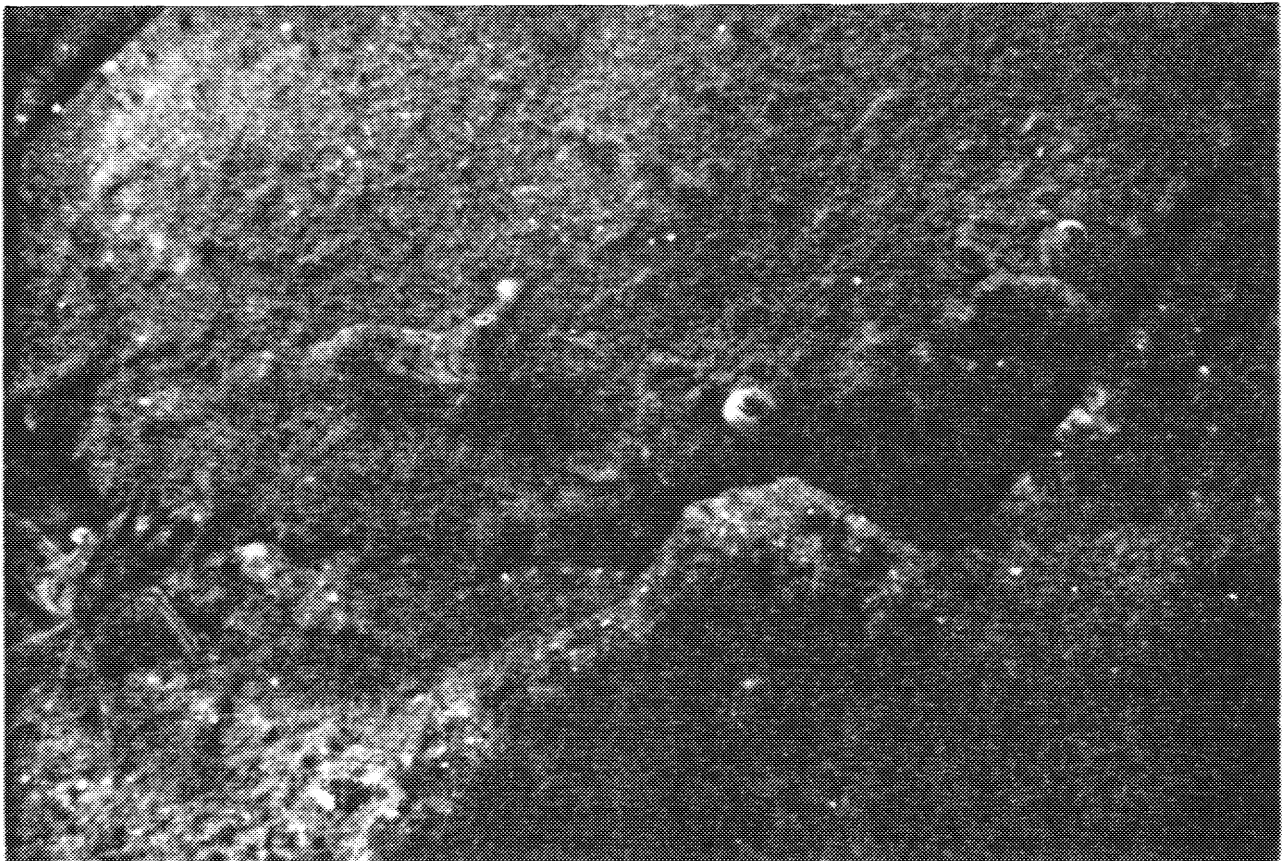
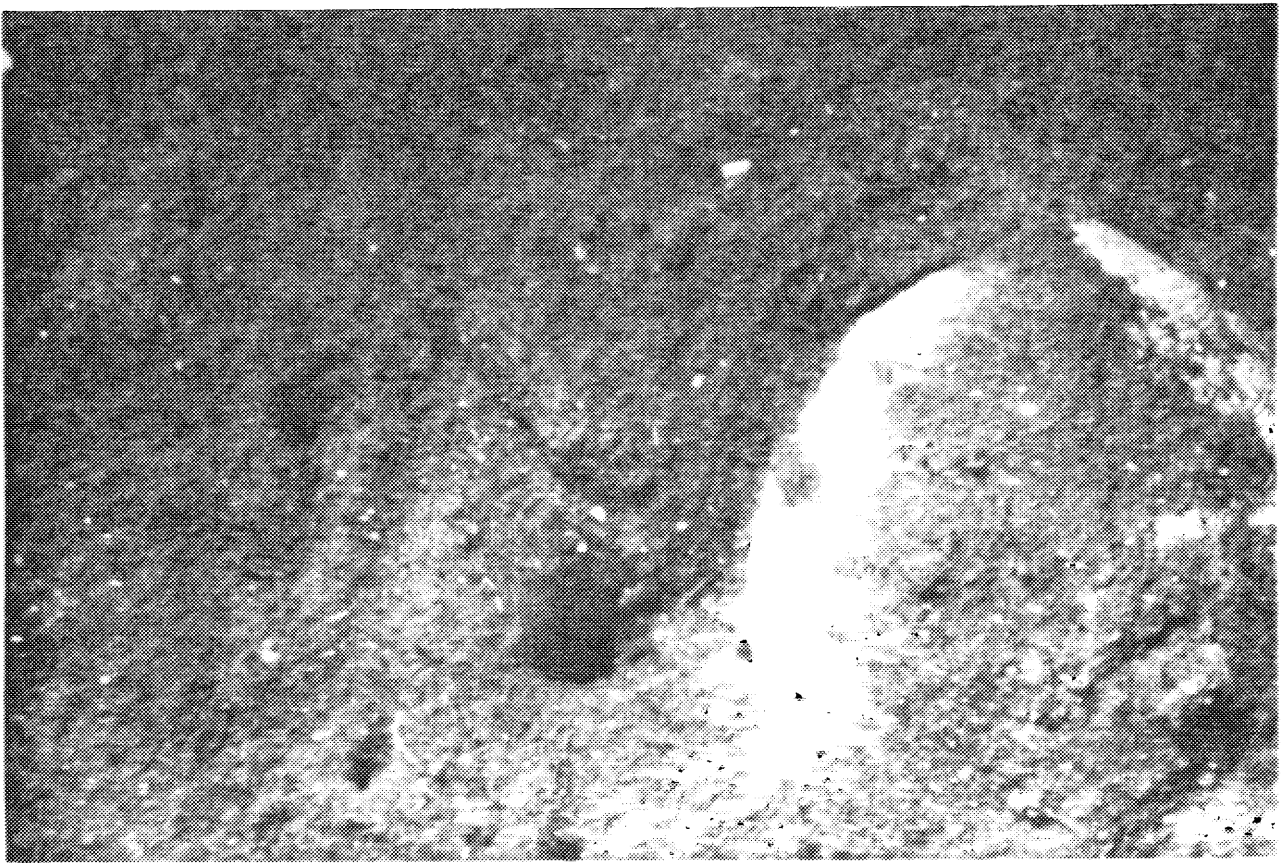
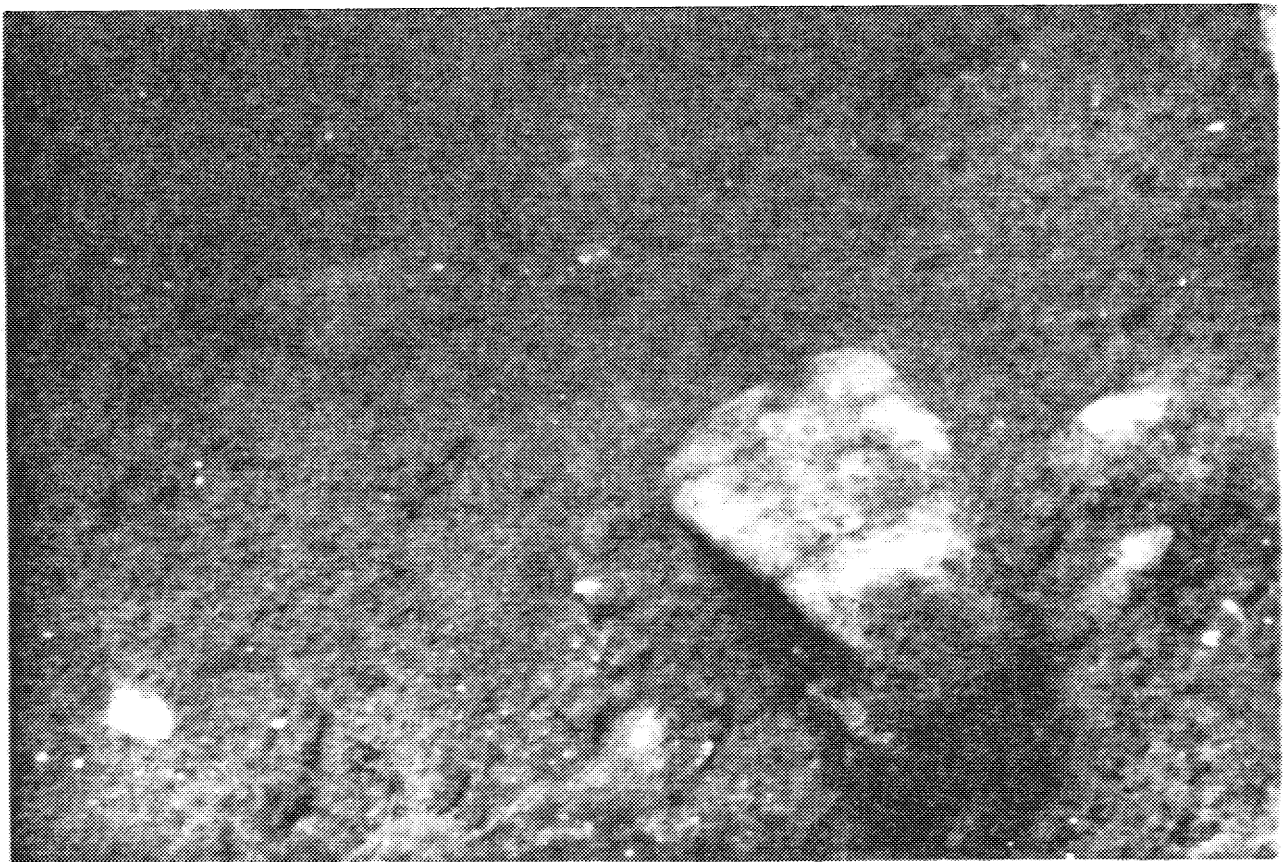
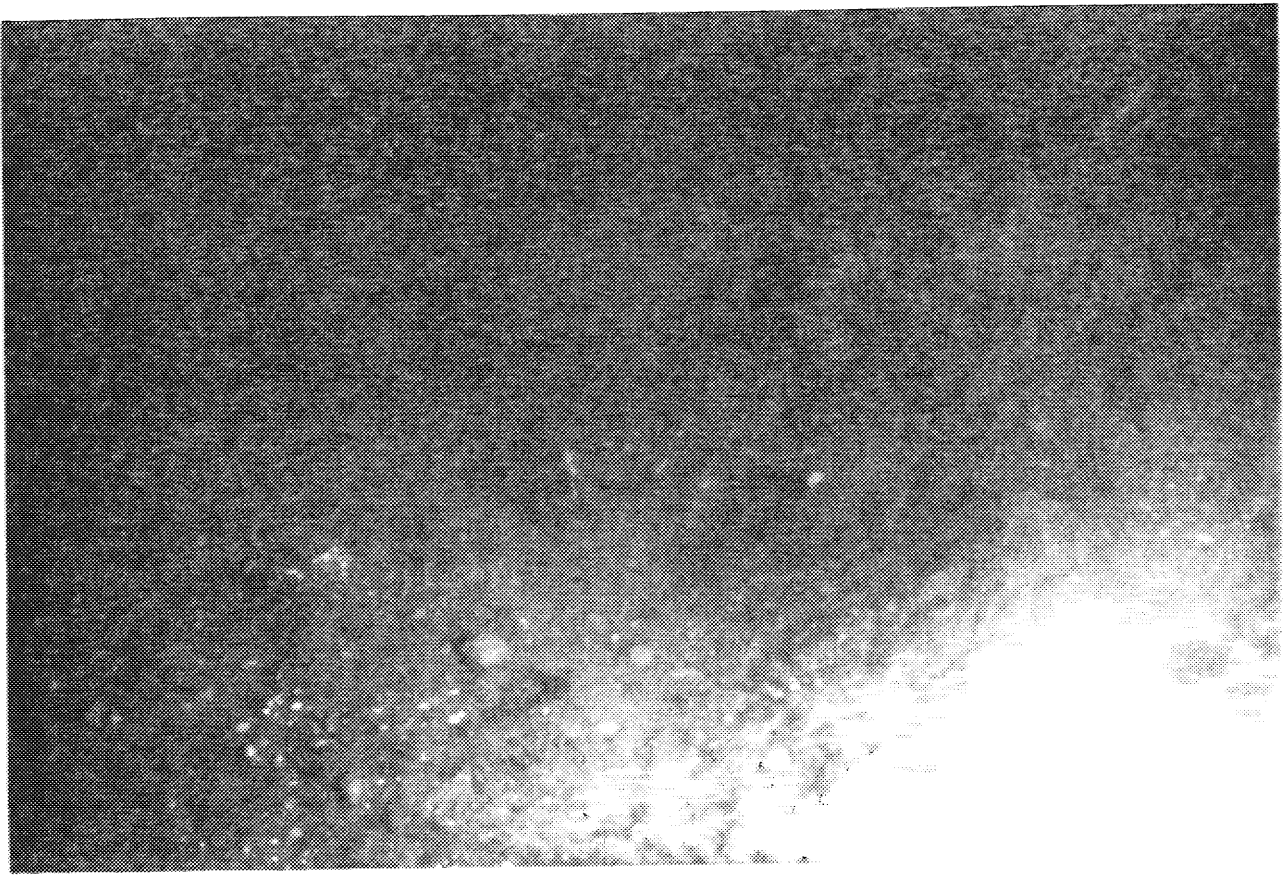
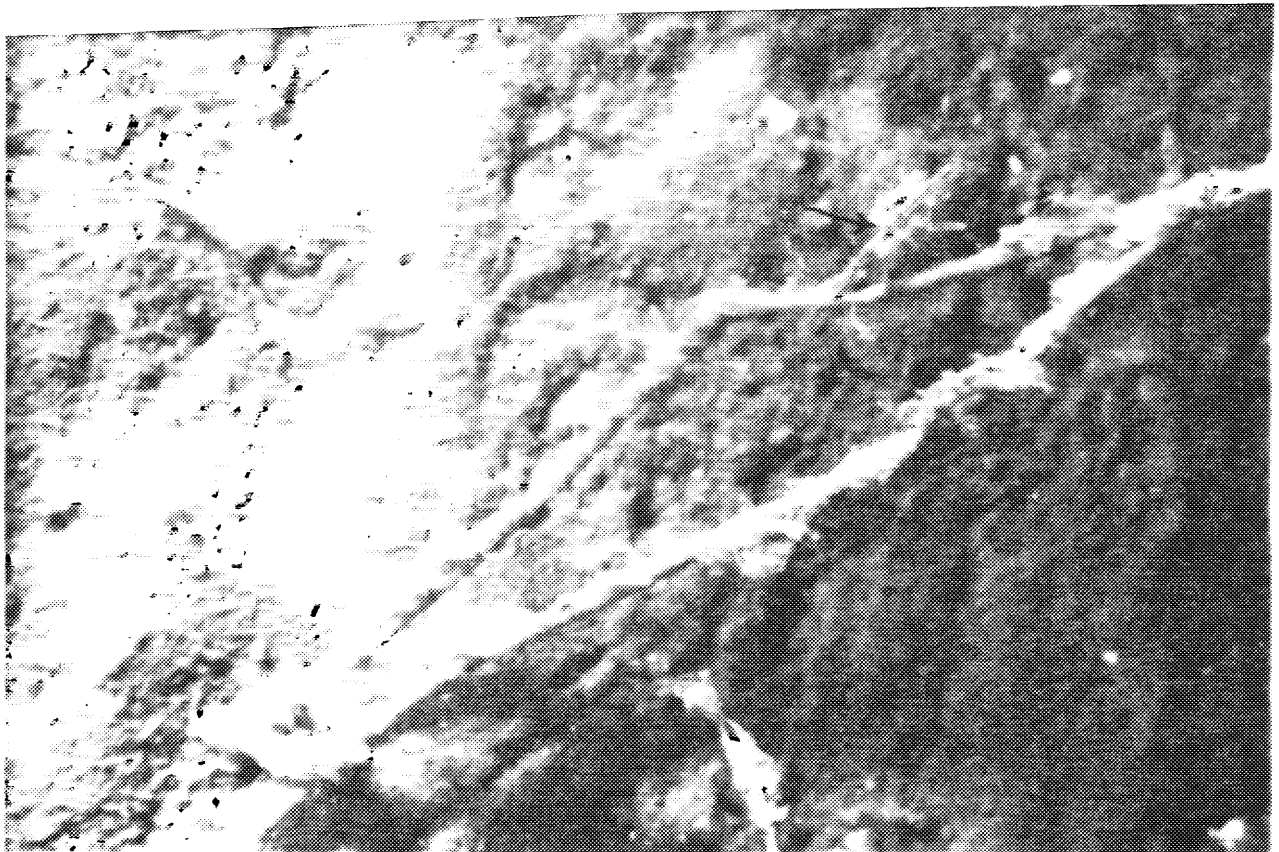
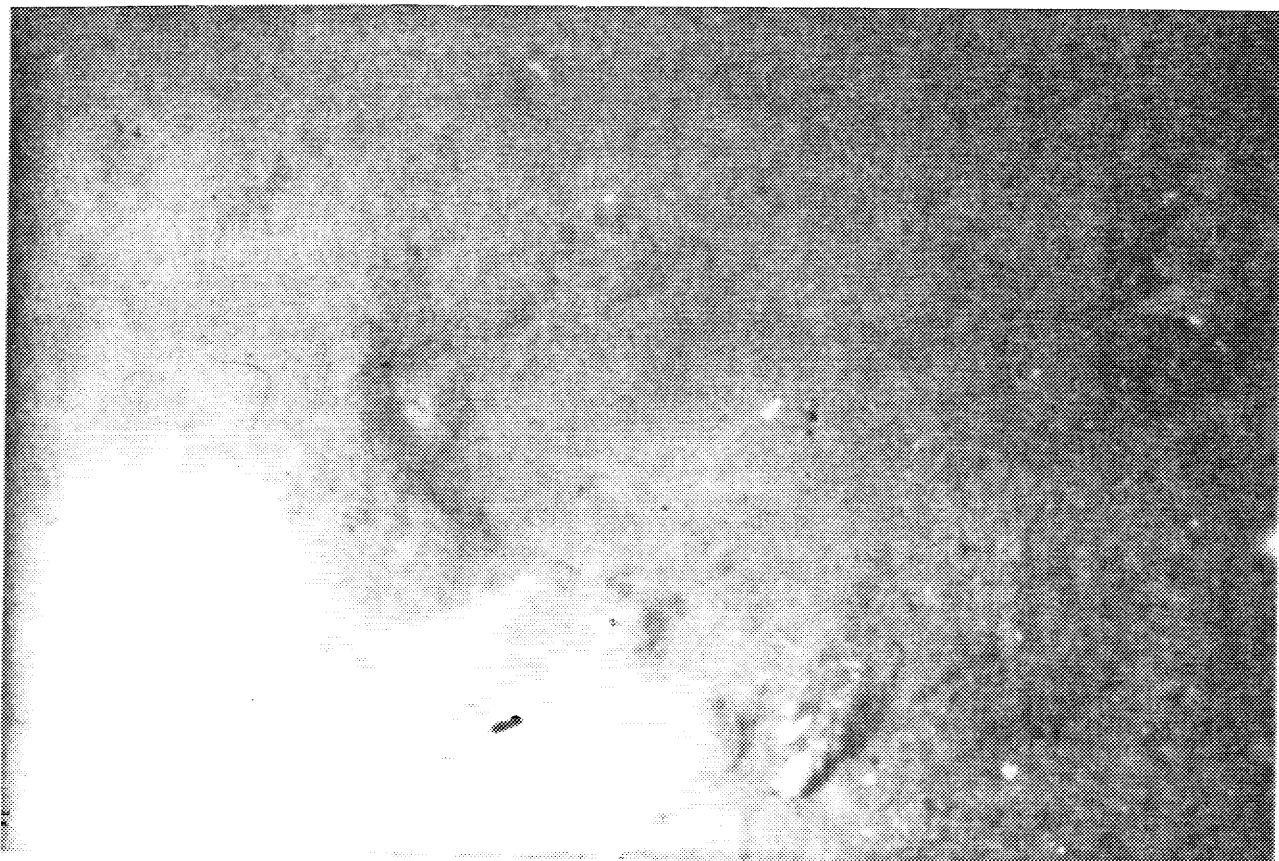
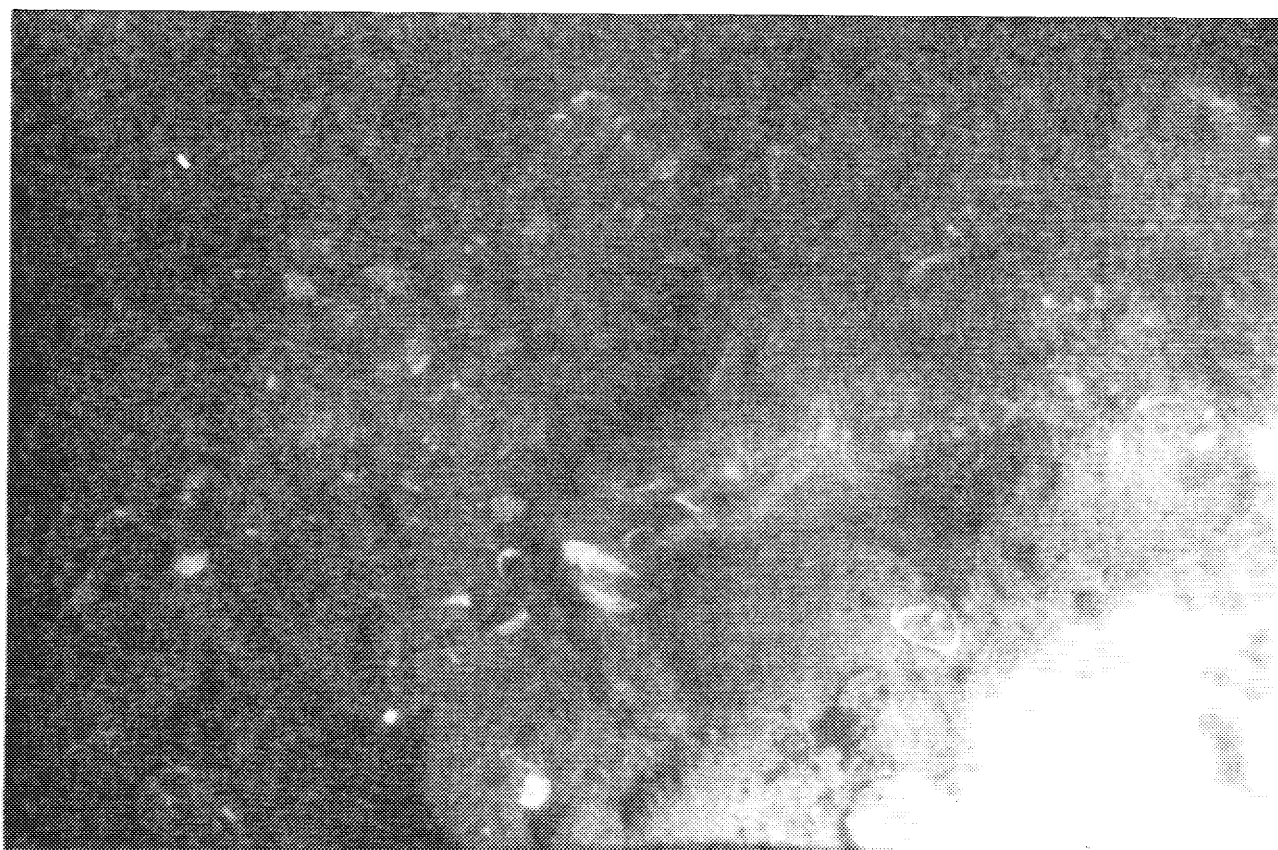
Figure 3.0-4a A boreal shrimp, Dichelophandalus leptocerus is shown within the left margin of a sediment cavity created by a burrowed hermit crab, Pagurus pollicaris. Note sediment plume created by Pagurus during feeding behavior.

Figure 3.0-4b Two boreal shrimp flank the anterior carapace of Cancer borealis, burrowed to carapace depth in the coarse sand surface cap.

Figure 3.0-4c Homarus americanus, burrowed beneath cobble heavily fouled with hydroid and bryozoan growth.

Figure 3.0-4d Denuded hydroid stalk (Tubularia) with associate epifauna caprellid amphipod (arrow).

Figure 3.0-4e Mercenaria shell and numerous small vertical burrows indicated extensive sediment reworking.

Figure 3.0-4f Cobble on sediment surface suggested recent turnover and new hydroid growth due to active bioturbation of surface substrate.

Figure 3.0-4g Alcove excavations on top of the historic spoil region revealed constant use by a wide range of species for shelter or food source.

Figure 3.0-4h A rough post-spoil terrain was formed by exposed shellhash and a cobble/boulder substrate. Niche space illustrates attraction of the hake, Urophycis.

Bottom photographs obtained during these dives are presented in Figures 3.0-4(a-h).

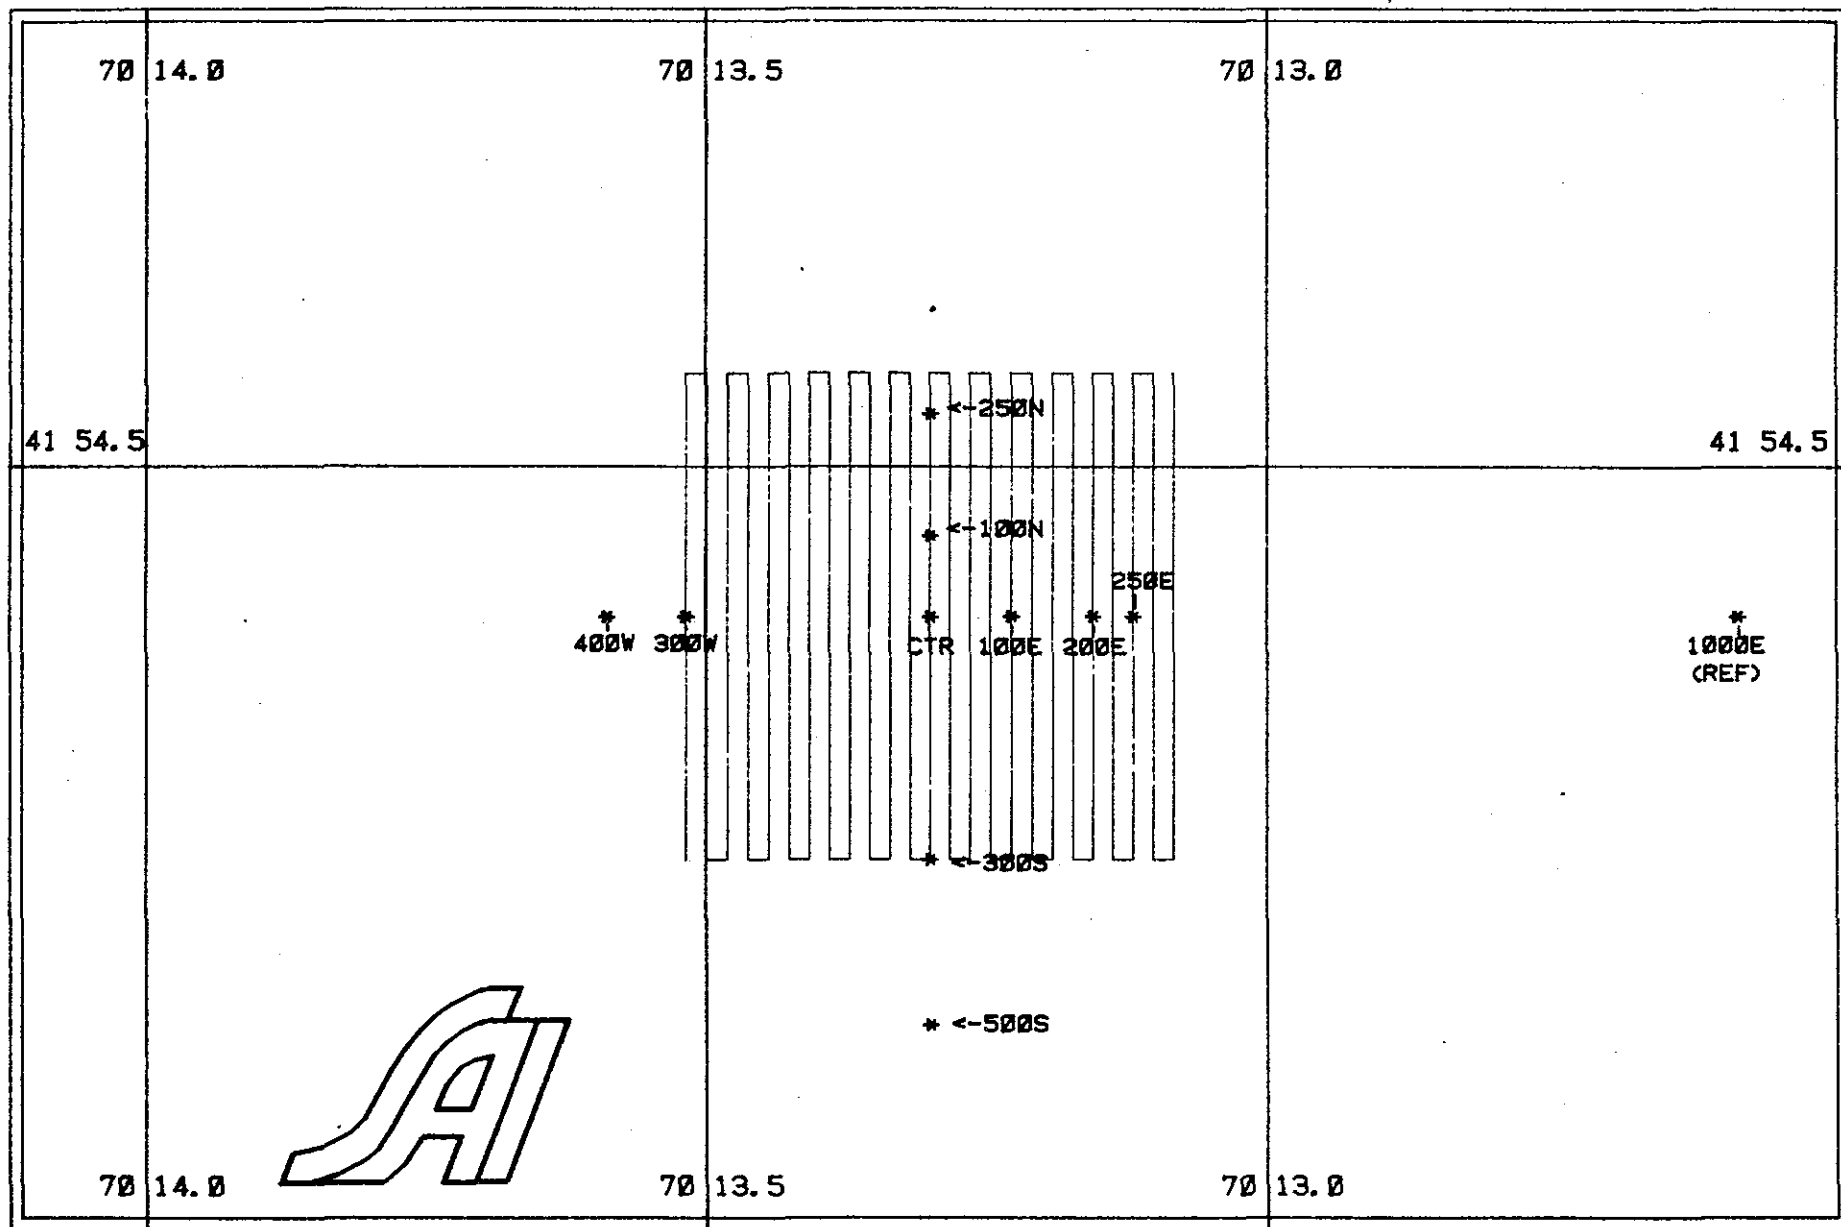
Fig. 4.0-5

WELLFLEET SEDIMENT SAMPLES

Following completion of the bathymetric survey, sediment samples were taken for chemical analysis and benthic biota investigations. All samples are now undergoing analysis and results will be provided as they become available. The locations and types of samples obtained are presented in Table 4.0-1 and Figure 4.0-5. Five replicates were taken for biological investigations at the center of the site, at the outer edge of dredged material on natural bottom 250 m east of the center, and
